Date Issued: September 27, 2010

Subject: Loose Camera head assembly

Model Affected: TT-02RX

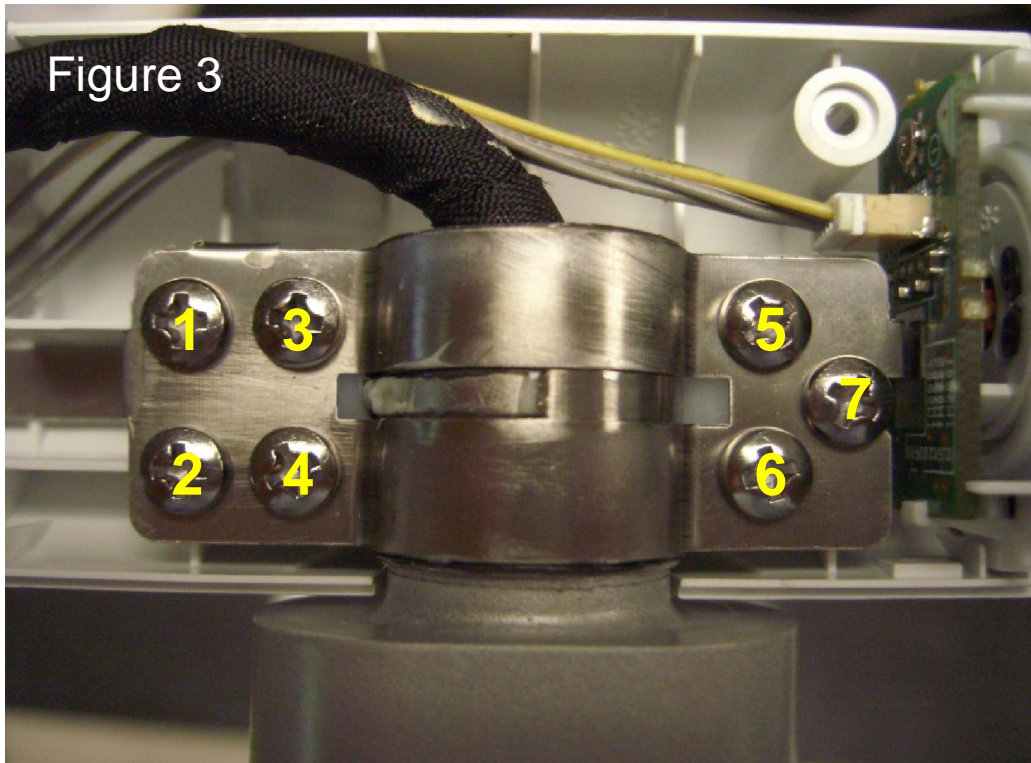
Symptom: Camera head will not stay in horizontal position

It has come to our attention that certain TT-02RX units have been shipped with less than the required torque applied to the screws that tighten the camera head assembly, which keeps the assembly in the horizontal position. The following fix should be applied to remedy the problem.

Step 4: Tighten seven (7) screws (using #2 Philips driver) following the number sequence in Figure 3. Ensure that the head assembly is in the horizontal position prior to tightening. **WARNING:** Do not over tighten the screws. Doing so will cause the plastic underneath to strip and the screw will be unable to hold properly.
