Model: TT-02RX

Date Issued: March 25, 2011

Subject: Troubleshooting Guide

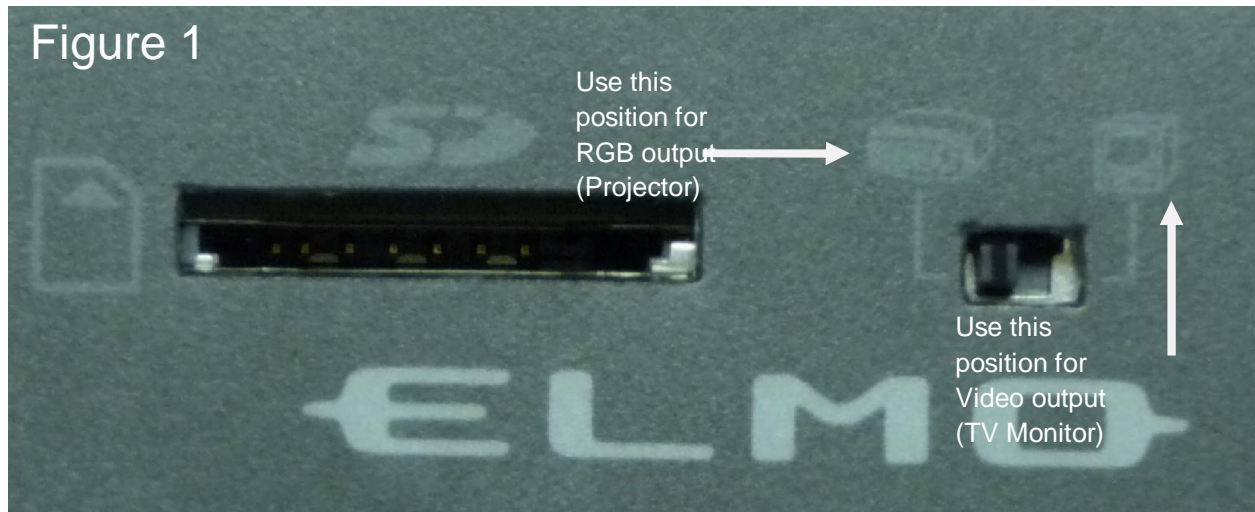
Issue: No Image from Document Camera output

Most Common Cause: The output selection switch is set to the improper position.

Solution: Reset output selection switch to proper position (See Figure 1)
