Model: TT-02s

Date Issued: March 25, 2011

Subject: Troubleshooting Guide

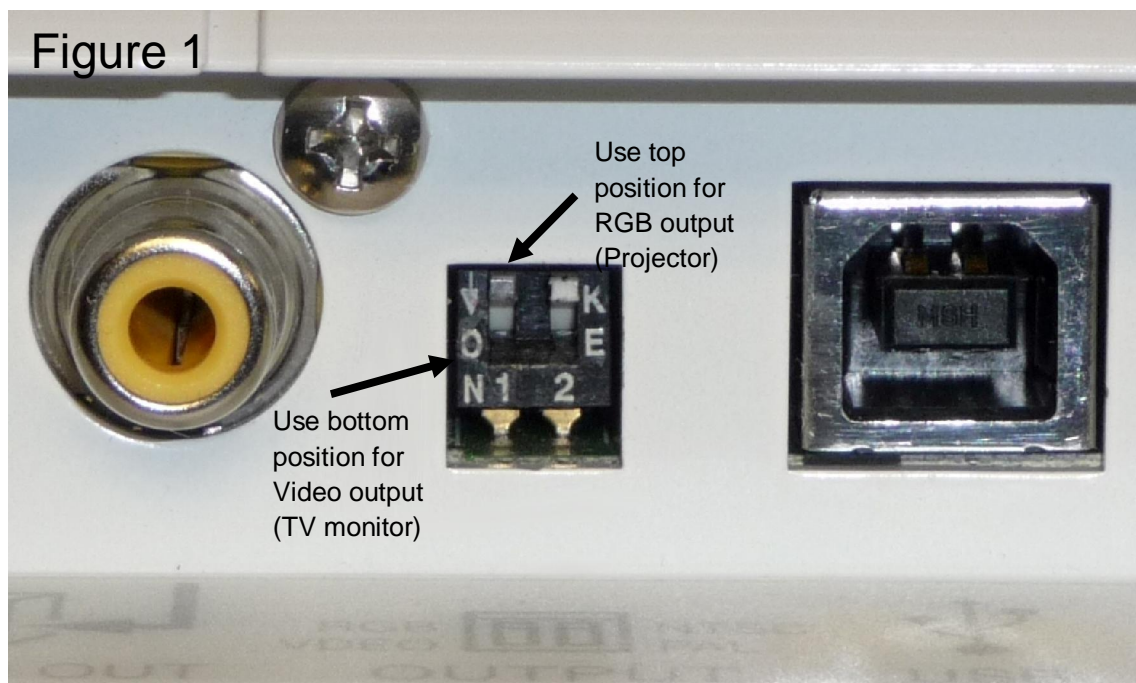
Issue: No Image from Document Camera output

Most Common Cause: The output selection switch is set to the improper position.

Solution: Reset output selection switch to proper position (See Figure 1)
