Model: TT-02u

Date Issued: March 25, 2011

Subject: Troubleshooting Guide

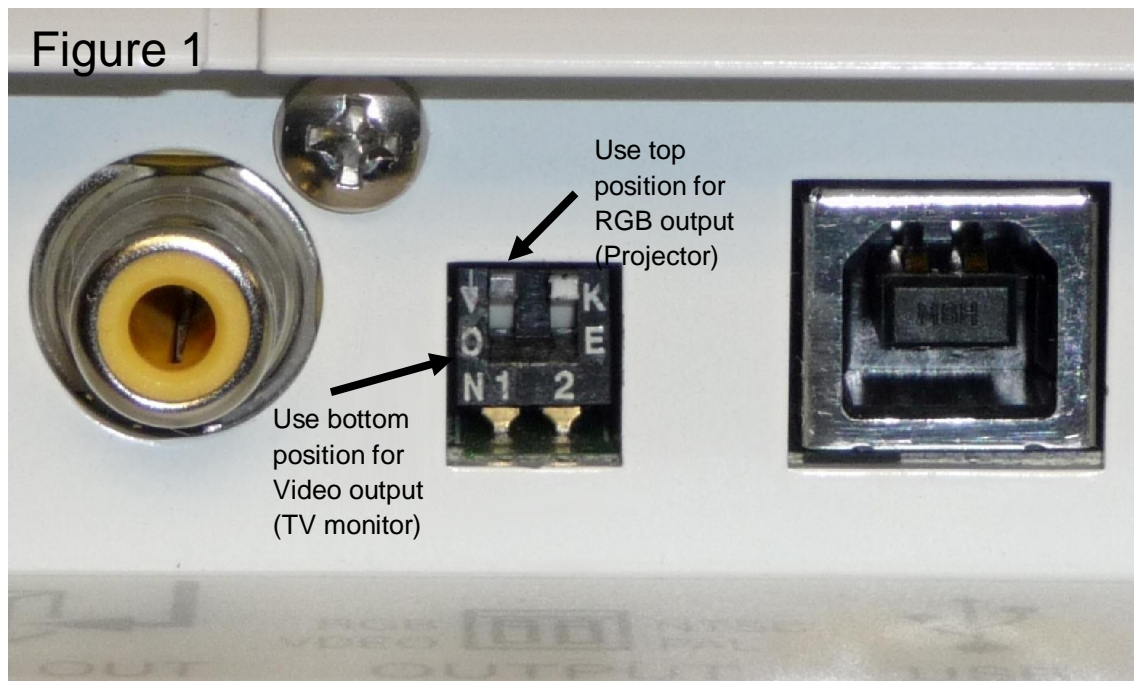
Issue: No Image from Document Camera output

Most Common Cause: The output selection switch is set to the improper position.

Solution: Reset output selection switch to proper position (See Figure 1)
